REPORT NO. 3550

THE RIVER TERMINAL RAILWAY COMPANY

IN RE ACCIDENT

Report No. 3550
 The River Terminal Railway
 Cleveland, Ohio
 November 30, 1953

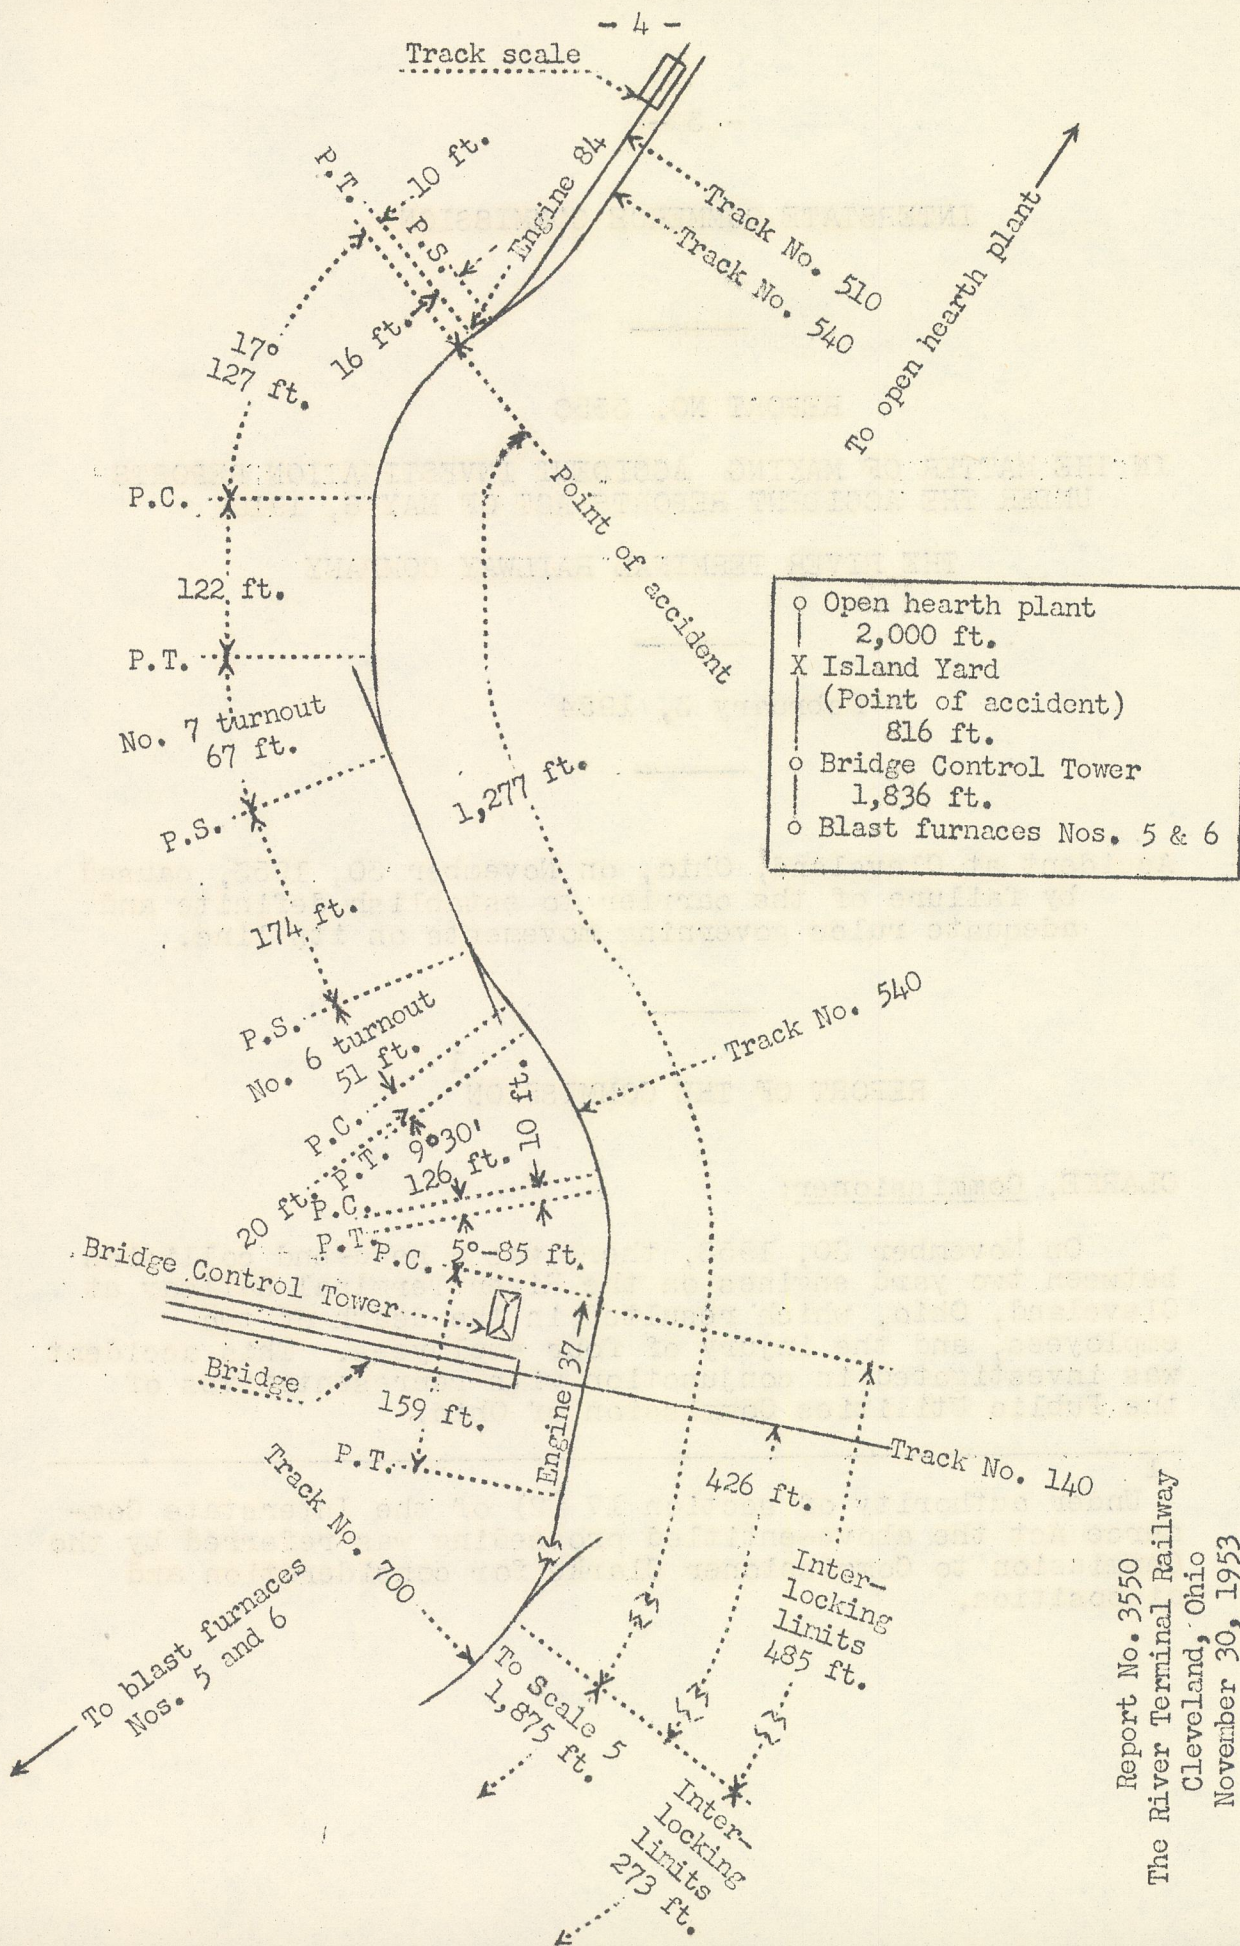
Location of Accident and Method of Operation

This accident occurred in the Island Yard of the River Terminal Railway at Cleveland, Ohio. This carrier performs switching and transfer service for steel plants of the Republic Steel Company located within the city. Train and engine movements are governed by operating rules of the carrier. The yard of blast furnaces Nos. 5 and 6, Island Yard, and the yard of an open hearth steel plant, together with connecting trackage, are located on the east side of the Cuyahoga River. A track scale designated as Scale No. 5 is located on a yard track at a point approximately 500 feet north of the gate of the plant of blast furnaces Nos. 5 and 6. A running track designated as track No. 700 connects the north ends of yard tracks in the vicinity of this plant immediately north of Scale No. 5 and extends northward and is parallel to the east bank of the river. A running track designated as track No. 540 diverges from track No. 700 at a power-operated switch located 1,875 feet north of Scale No. 5. Track No. 700 extends in a northeasterly direction from this point, and track No. 540 extends northward via Island Yard to the yard of the open hearth steel plant. The accident occurred on track No. 540 at a point 1,277 feet north of the south switch. In Island Yard a track scale is located on track No. 510. The south switch of this track is located in track No. 540 immediately north of the point of accident. From the south on track No. 540 there are, in succession, a tangent 159 feet in length, a 5° curve to the left 85 feet, a tangent 10 feet, a 9°30' curve to the left 126 feet, a tangent 20 feet, a No. 6 turnout to the right 51 feet, a tangent 174 feet, a No. 7 turnout to the right 67 feet, a tangent 122 feet, and a 17° curve to the right 127 feet to the point of accident and 10 feet northward. The grade for north-bound movements on track No. 540 is, successively, 2.22 percent ascending a distance of 293 feet, 1.05 percent ascending 71 feet, 0.42 percent descending 100 feet, 1.34 percent descending 214 feet, 1.18 percent descending 283 feet, 0.59 percent ascending 105 feet, 1.07 percent ascending 115 feet, and 1.63 percent ascending 33 feet to the point of accident and 152 feet beyond.

Engine 37, headed southward and moving in backward motion and pulling two loaded hot-metal cars, departed from Scale No. 5 and entered track No. 700 a few minutes before the accident occurred. This movement proceeded northward, was routed to track No. 540 at Bridge Control Tower, passed Bridge Control Tower about 2:57 a. m., and while moving at an estimated speed of 20 miles per hour it collided with engine 84 at a point 1,277 feet north of the south switch of track No. 540.
